Subject: Department of Natural Resources Washington Geological Survey,
School Seismic Safety Assessment Project, Contract No. AE 410 -
Seismic Evaluation for **Riverside School District**

School Buildings Evaluated in the Riverside School District

Riverside, Chattaroy Elementary School, 35 Wing Building

Riverside, Chattaroy Elementary School, Main Building

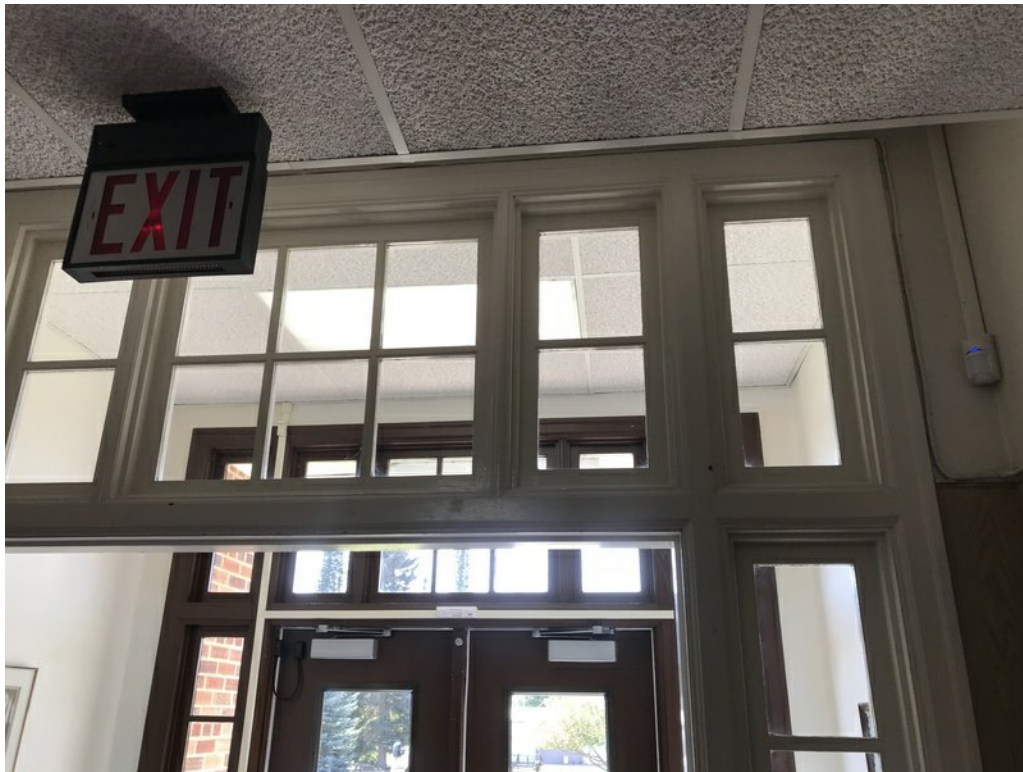
CG-8 Overhead Glazing. HR-not required; LS-MH; PR-MH.	Large window panes observed, but lamination could not be verified.
PCOA-1 URM Parapets or Cornices. HR-LMH; LS-LMH; PR-LMH.	Masonry veneer ratios could not be verified.
MC-2 Anchorage. HR-LMH; LS-LMH; PR-LMH.	This condition could not be observed.

Figure 1-1. Overhead glazing at front entry.

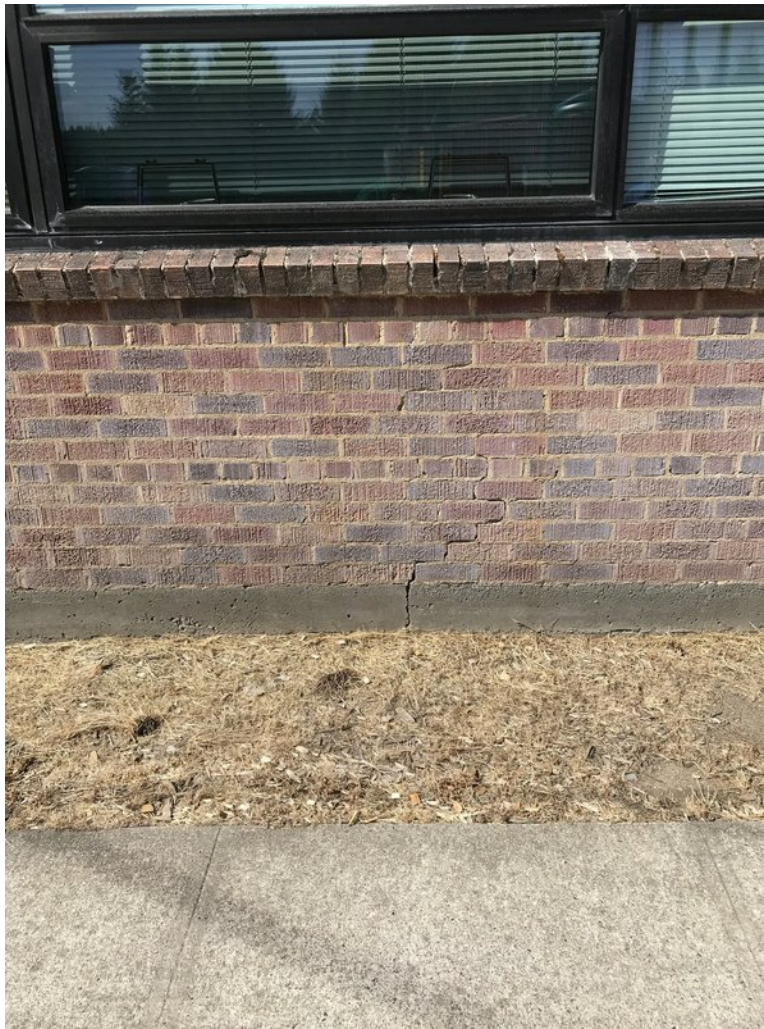
Structural System	Description
Structural Roof	Unknown. No visible signs of corrosion, damage or deterioration.
Structural Floor(s)	Good. No signs of corrosion, damage or deterioration.
Foundations	Unknown. No visible signs of corrosion, damage or deterioration.
Gravity System	Fair. Some signs of cracking and deterioration at exterior walls.
Lateral System	Fair. Some signs of cracking at exterior walls. It is recommended the deterioration and cracking be evaluated by a licensed structural engineer.

Figure 1-2. Cracking visible in the south face of the building.

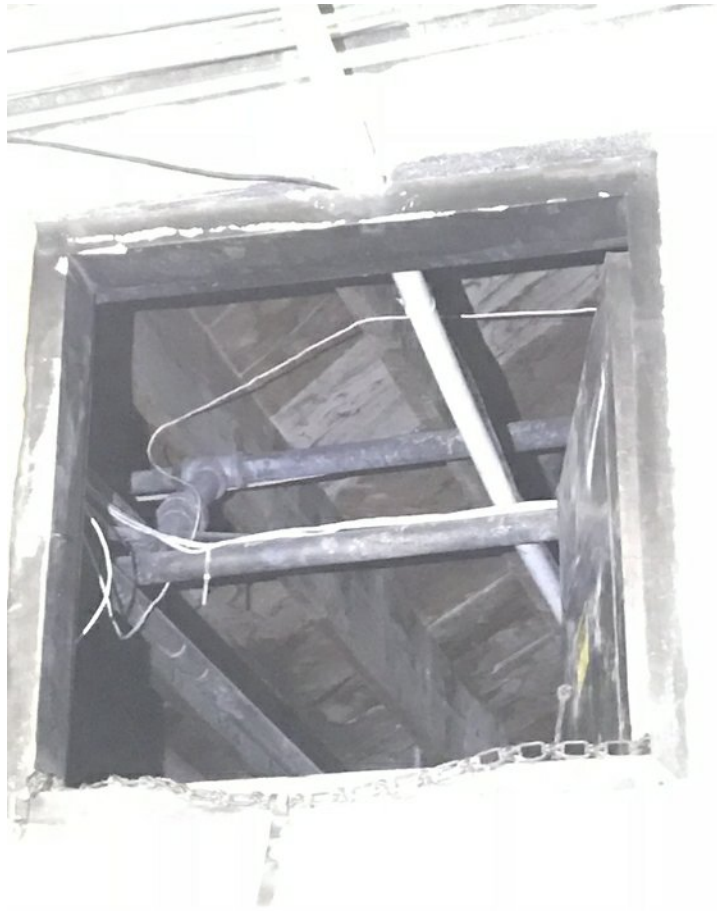
Figure 1-3. A glimpse of the roof structure through an access hole in the mechanical room.

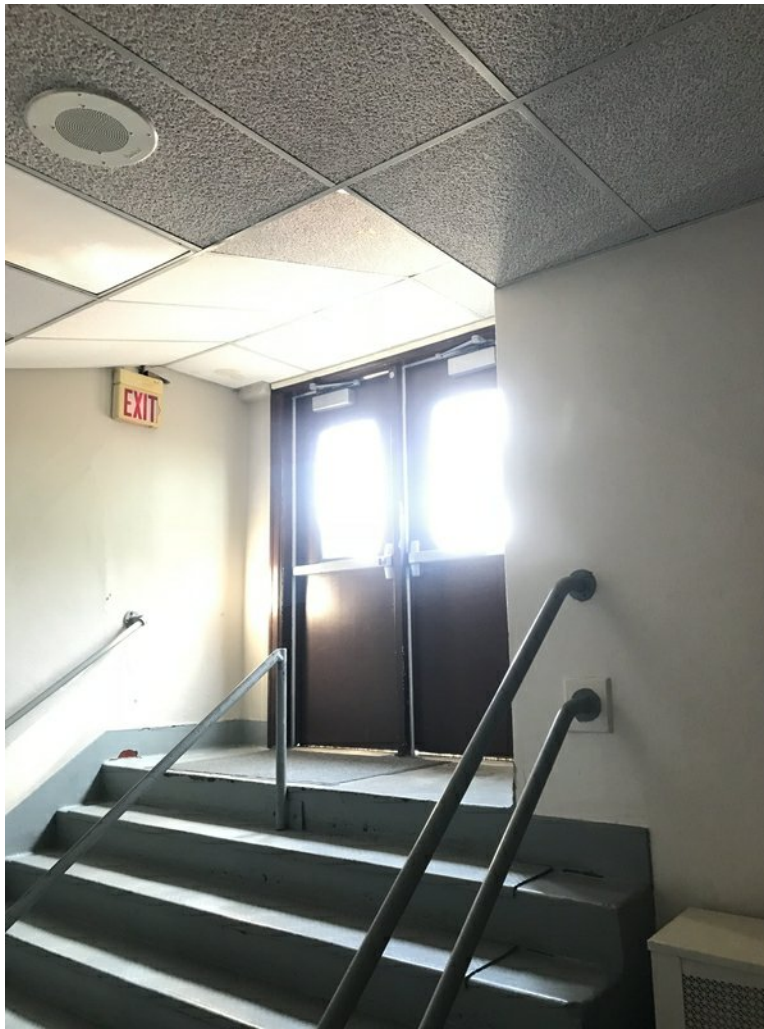
Figure 1-4. Stairway leading to covered walkway to main building.

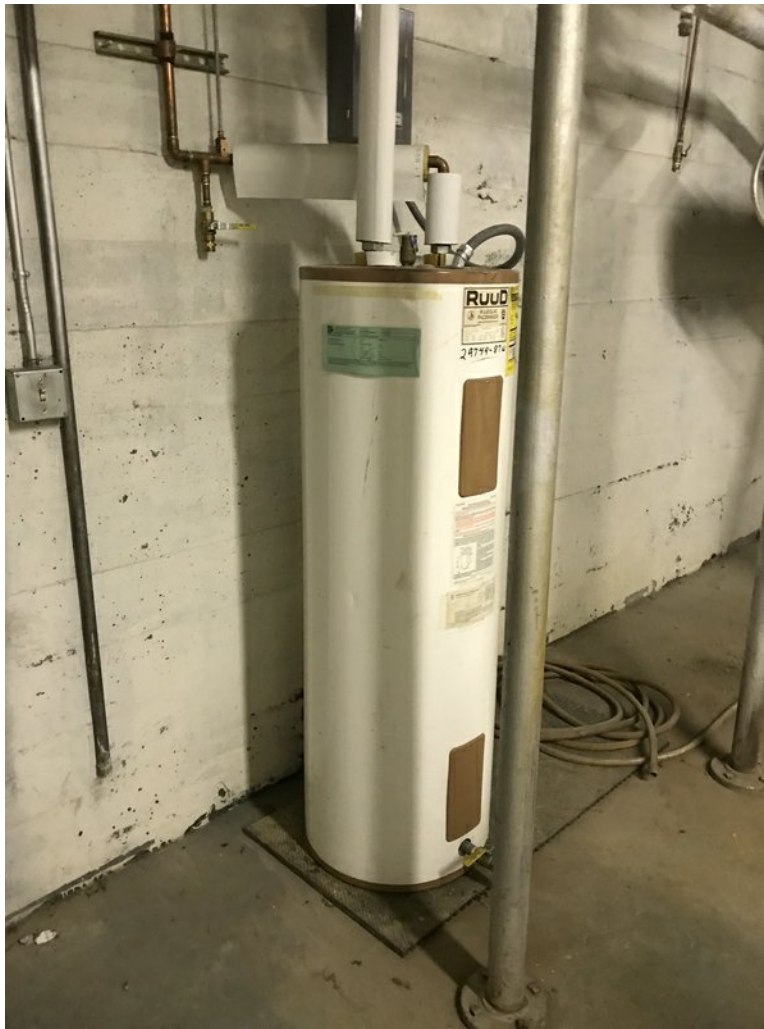
Figure 1-5. Unbraced water heater in basement mechanical room.

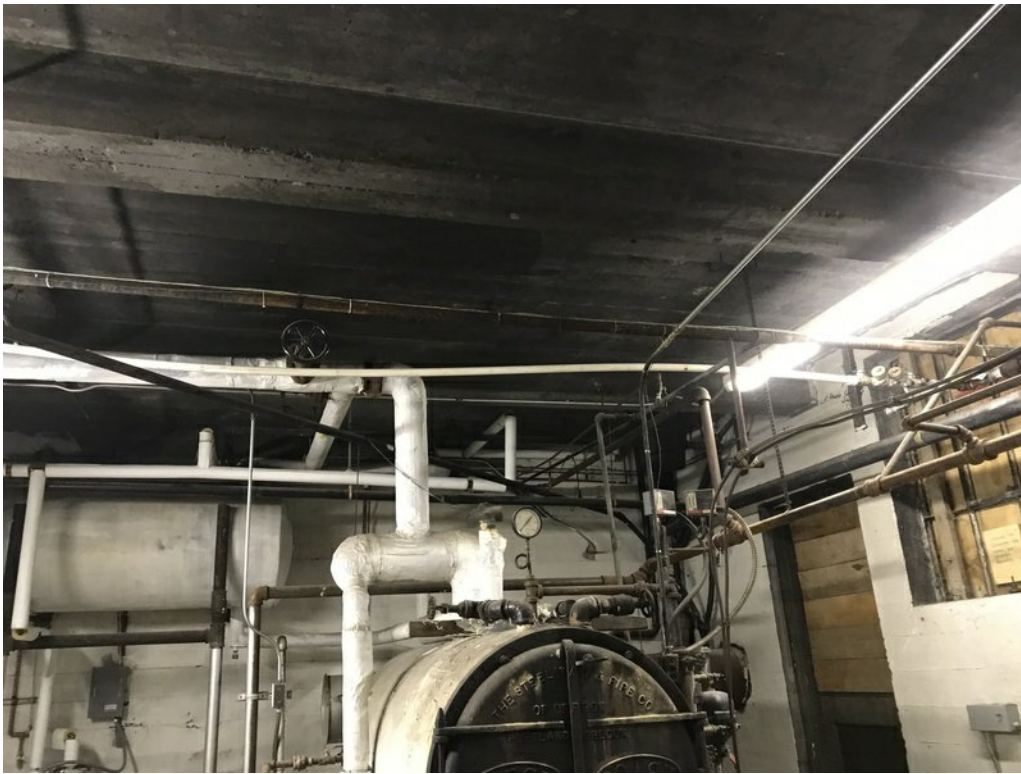
Figure 1-6. Boiler room in west wing basement near gymnasium. Ceiling shows board-formed concrete slab.

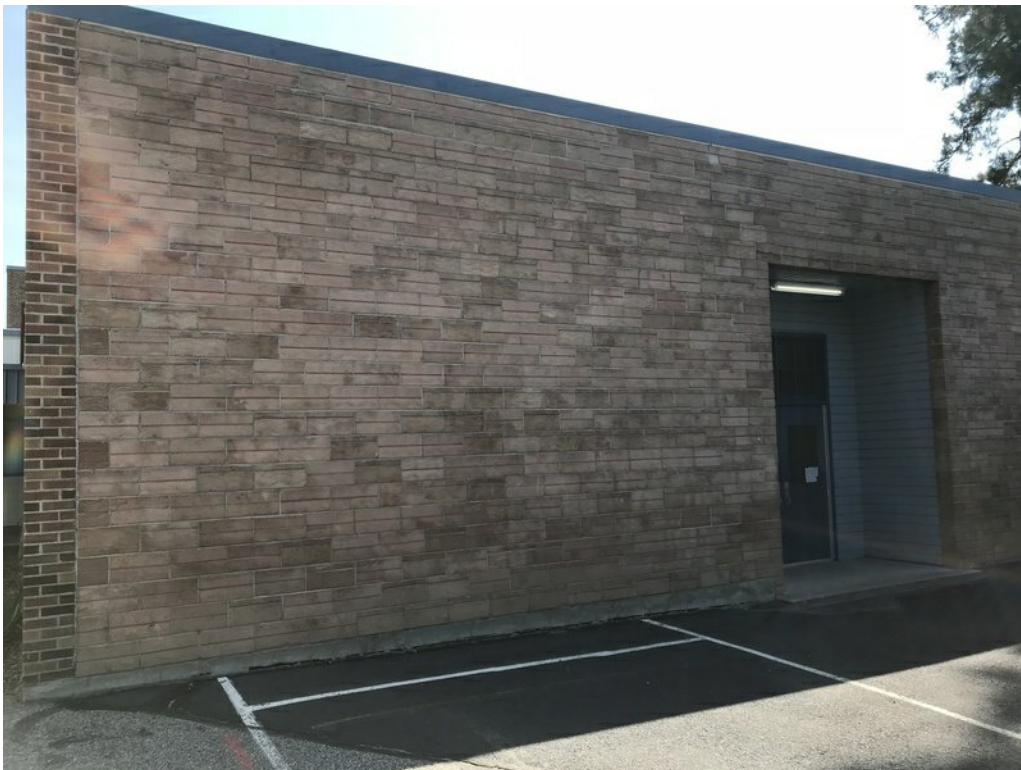
Figure 1-7. West end of building.

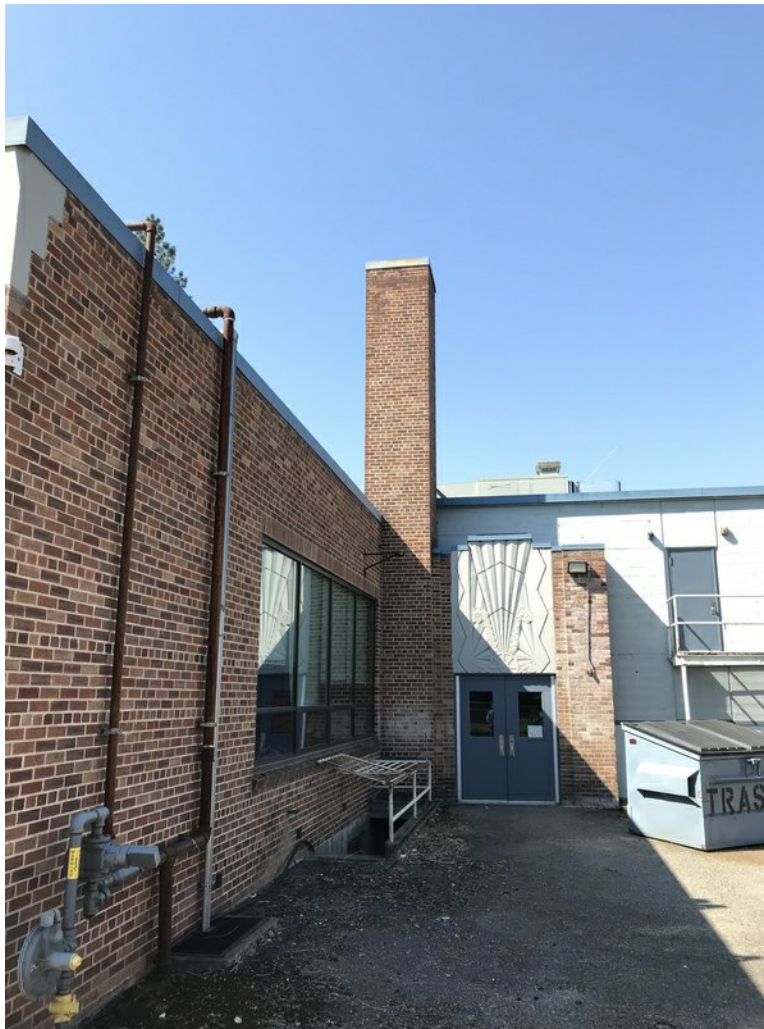
Deficiency	Description
MC-1 URM Chimneys. HR-LMH; LS-LMH; PR-LMH.	The height to width ratio of the chimney extension above the roof could not be measured due to limitations in access, but it appeared to exceed the limit noted.

Figure 1-8. South wall of west wing and west wall of gymnasium. Large URM chimney visible.

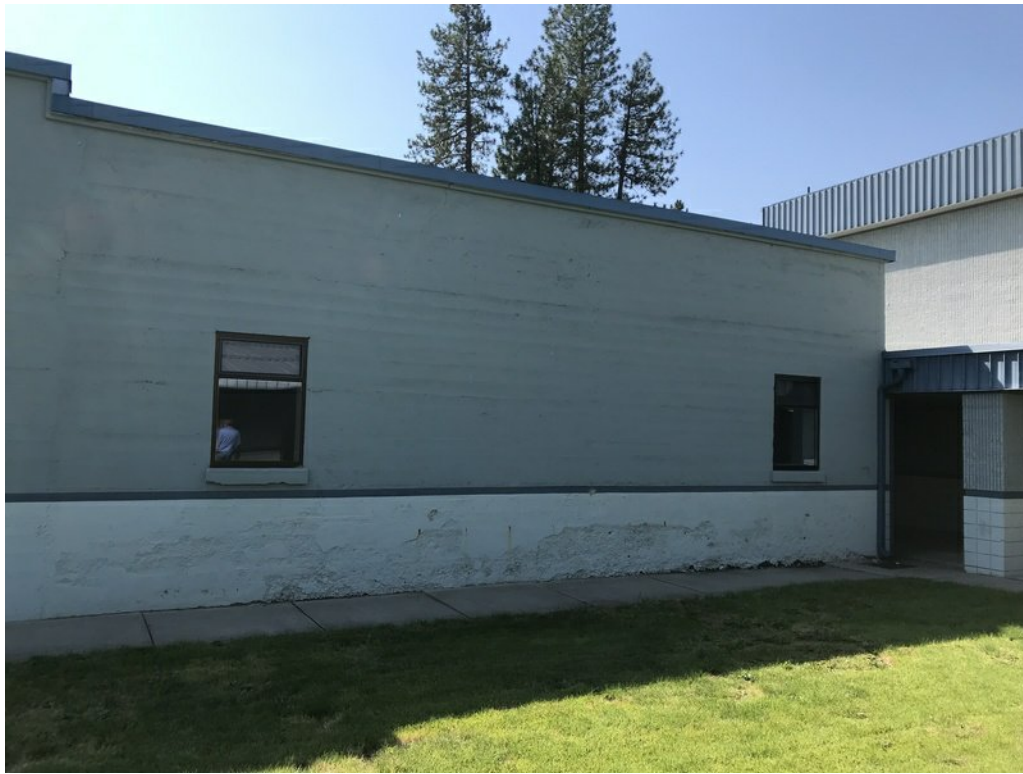
Figure 1-9. North wall of gym. Some signs of deterioration visible near sidewalk.

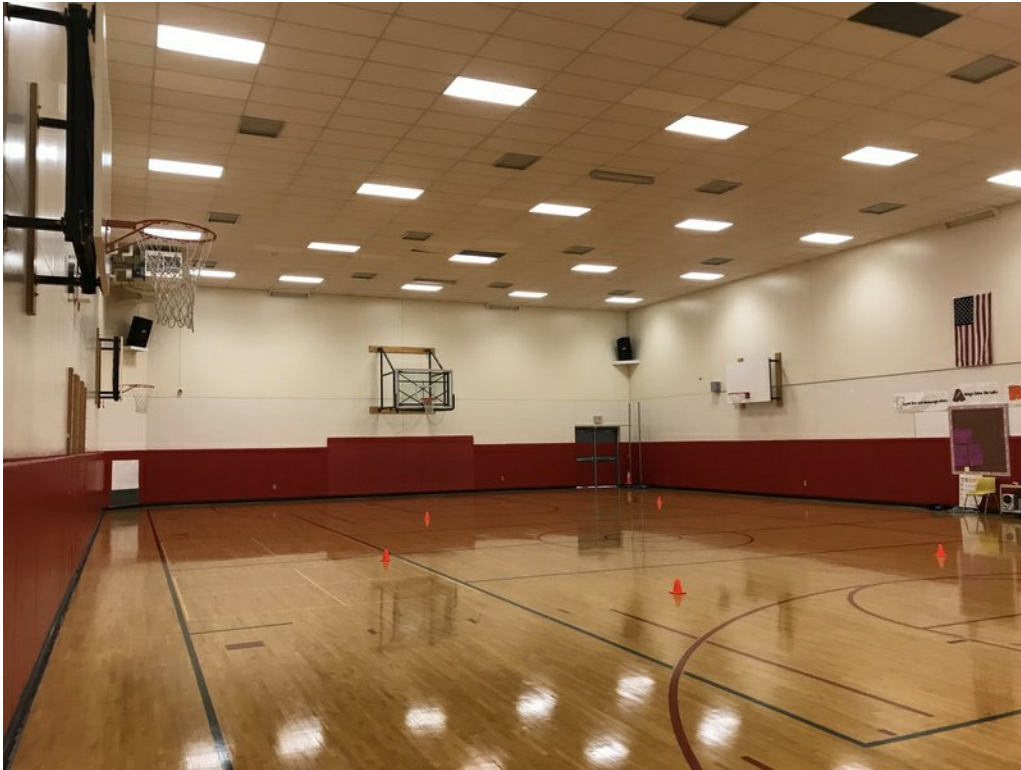
Figure 1-1. Gymnasium in east wing of building.

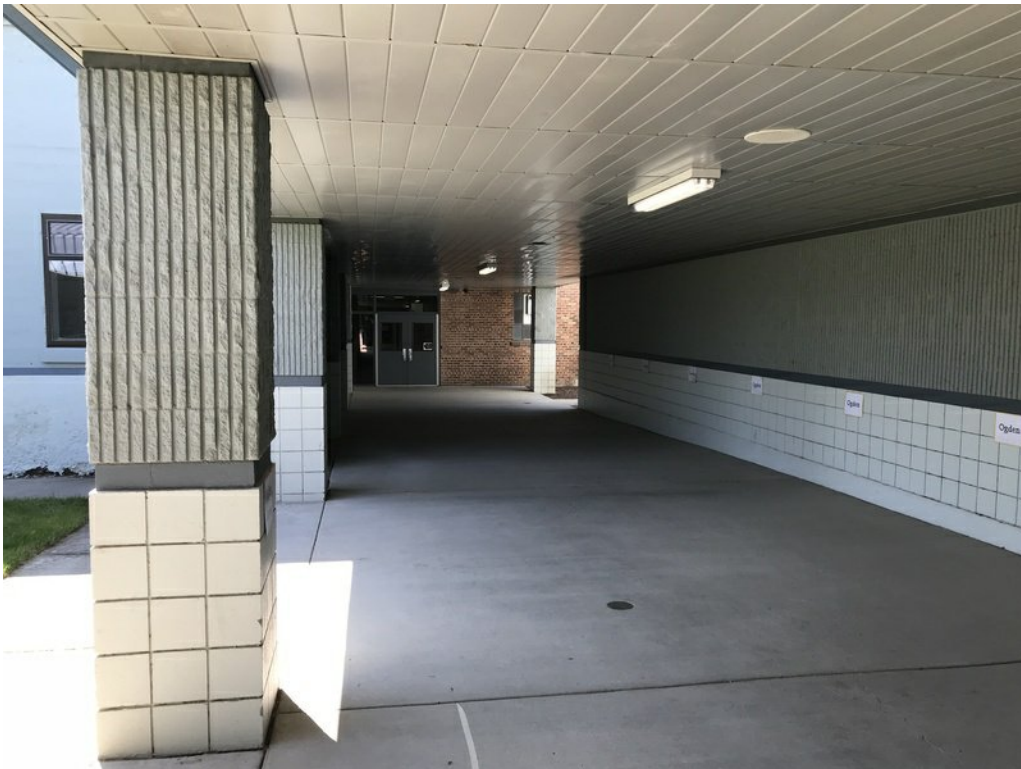
Figure 1-2. Covered walkway between '35 wing and main building.

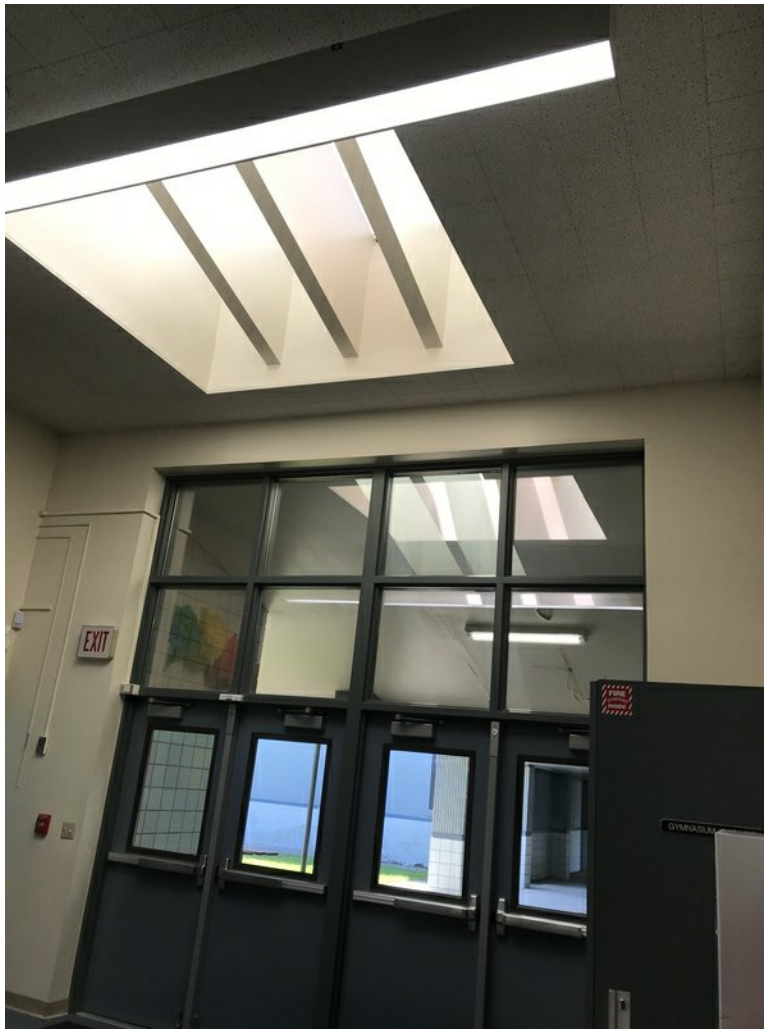
Figure 1-3. Entry at covered walkway.

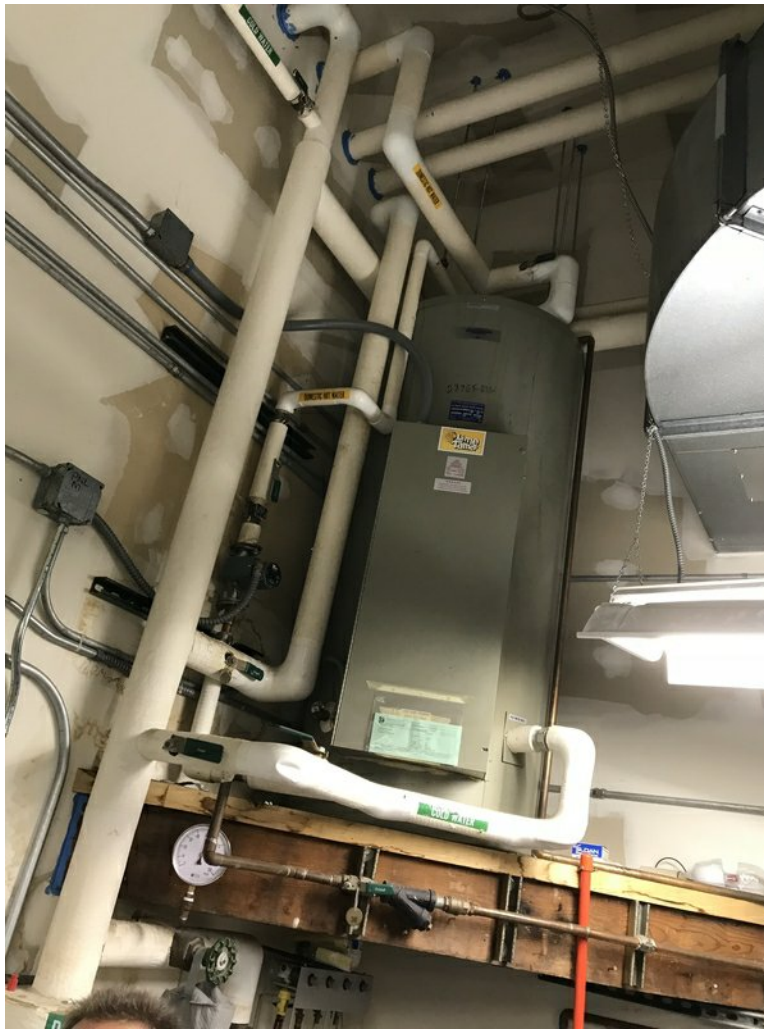
Figure 1-4. Elevated water heater in mechanical room.

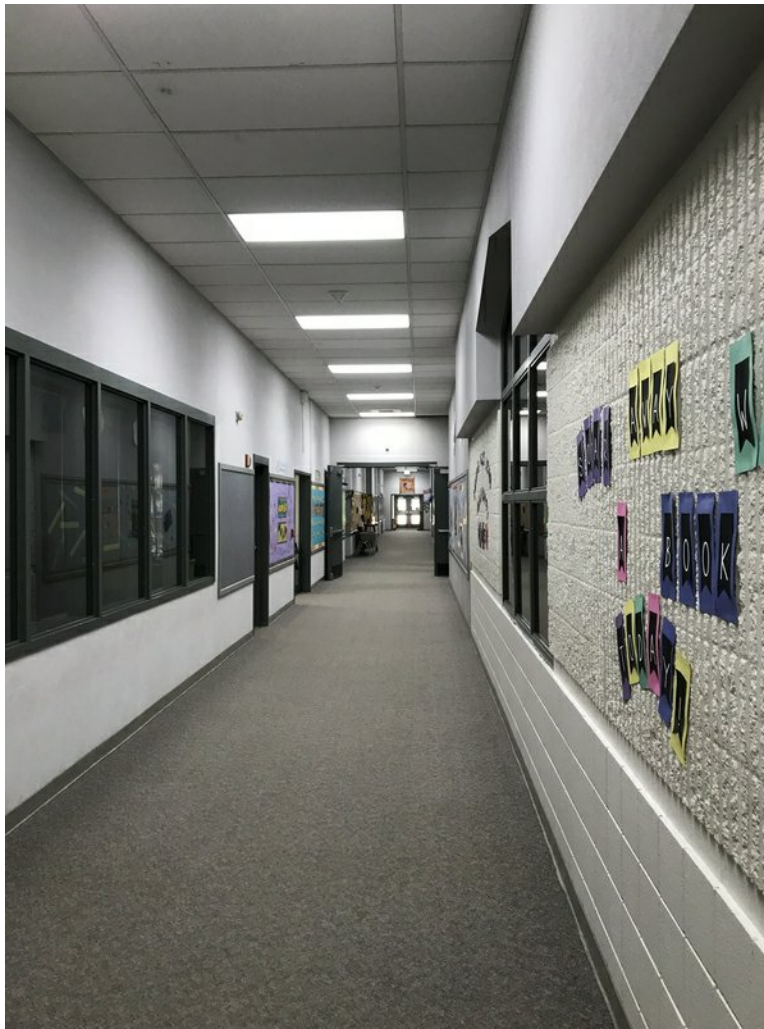
Figure 1-5. Corridor looking down north wing.

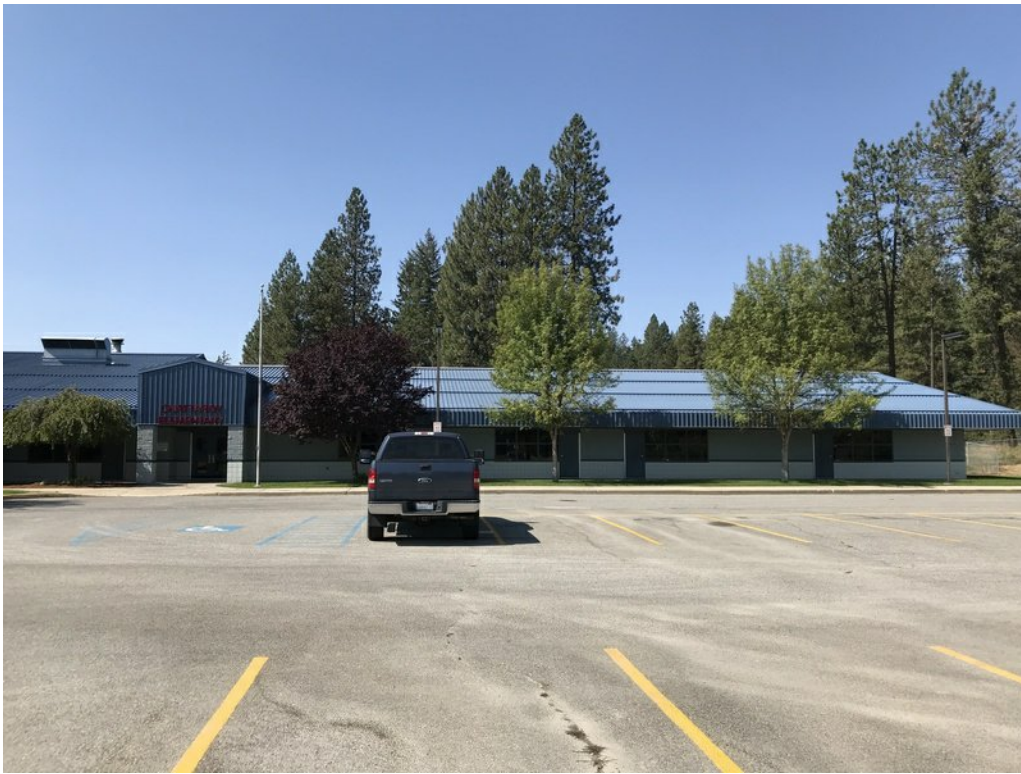
Figure 1-6. East elevation of north wing.

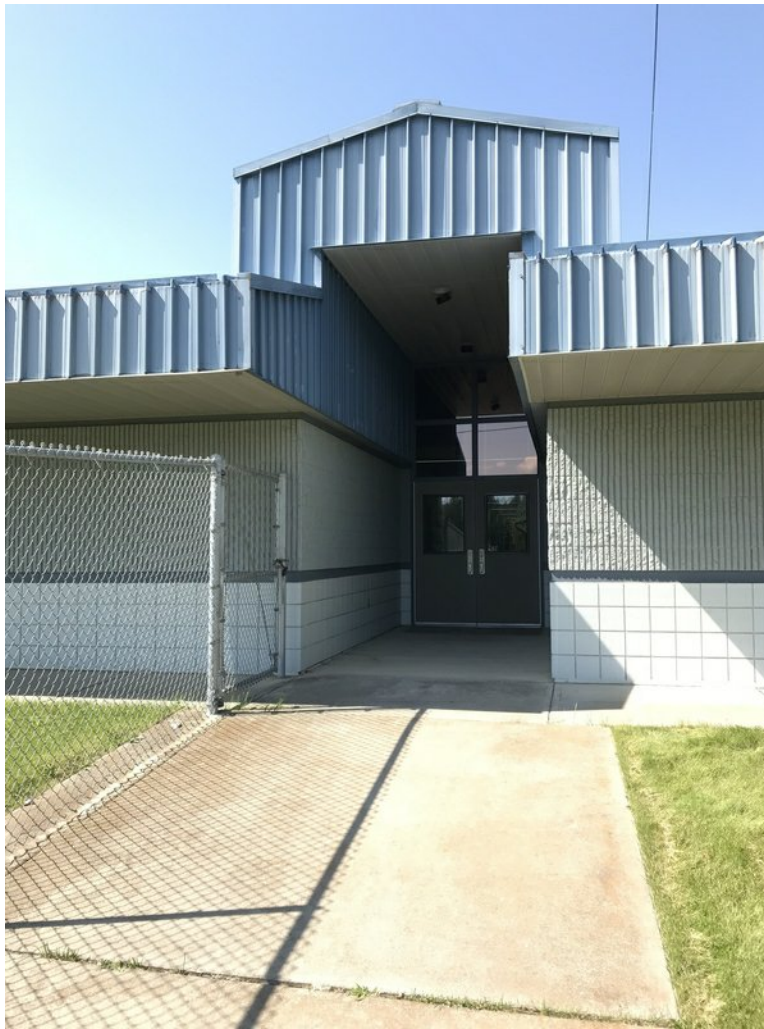
Figure 1-7. Entrance at east end of east wing.

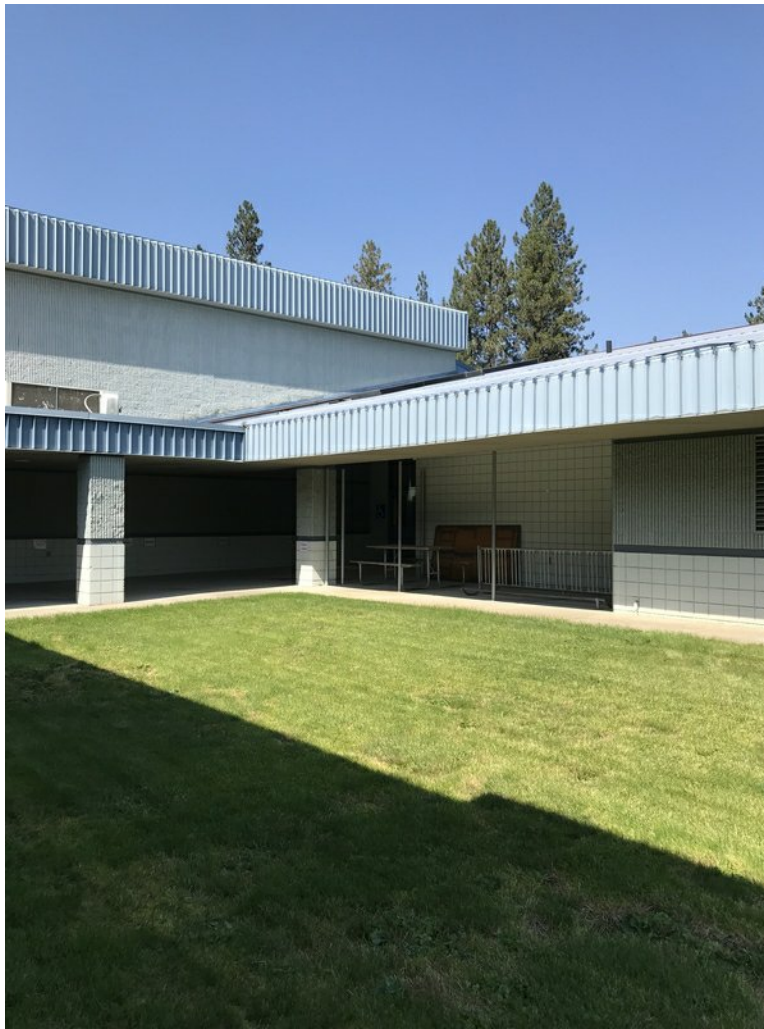
Figure 1-8. Covered patio at southeast corner of building.
